A Description of the Building as Initially Constructed

Building History, Description and Significance

Chronology of Development and Use 1.2

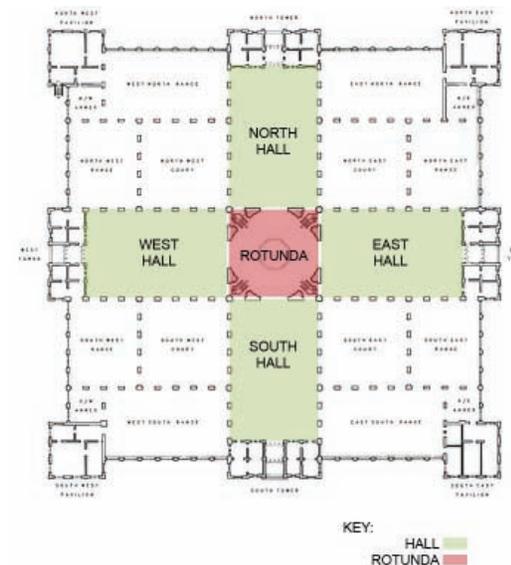
1. Identification plan Rotunda and halls

Each hall is identified by its cardinal direction and orientation (See Figure 1). All of the halls are open through a large open arch to the Rotunda. Rathbun's description of the layout is concise in the configuration of the primary exhibition spaces of the building:

The primary feature of the plan consists of four naves or main halls, the largest in the building, which radiate in the form of a Greek cross from a central rotunda to the towers above mentioned. Following the outer walls and extending from the naves to the pavilions are a series of eight ranges, two on each side. This arrangement leaves four courts, enclosed (sic) by the naves and ranges, which are roofed over and form parts of the actual building.⁸

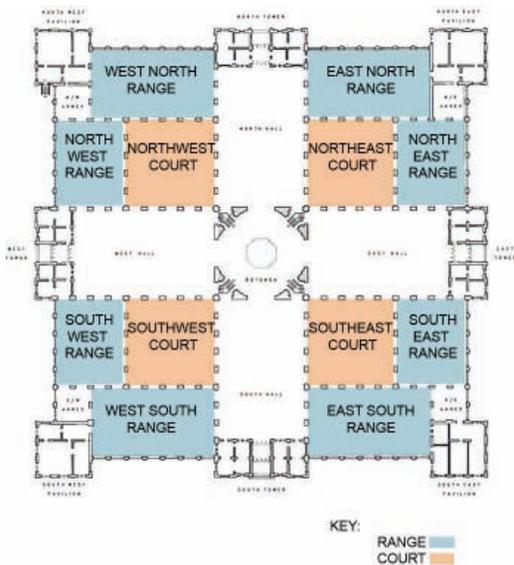
2. Identification plan

In each quadrant an inner court space was nestled at the corner where the halls join the Rotunda. The eight ranges extend from the tower ends of the halls enclosing the court elevations (See Figure 2).

Ranges and courts

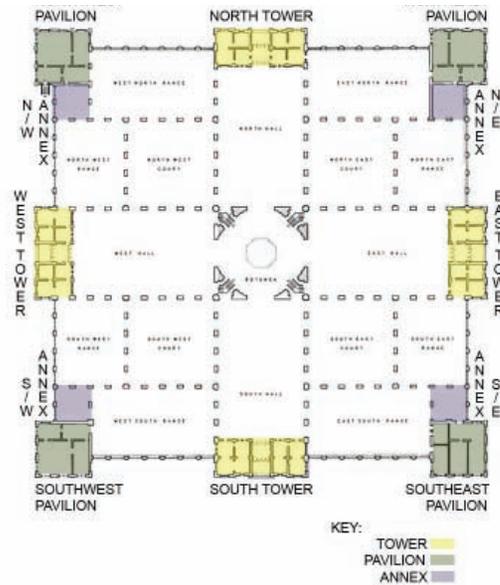
3. Identification plan

The pavilions and towers are divided into three levels and are designed to serve administrative and laboratory purposes. Basement spaces are accessed through the North East, North West, and South West Pavilions (See Figure 3).

Towers, pavilions, and annexes

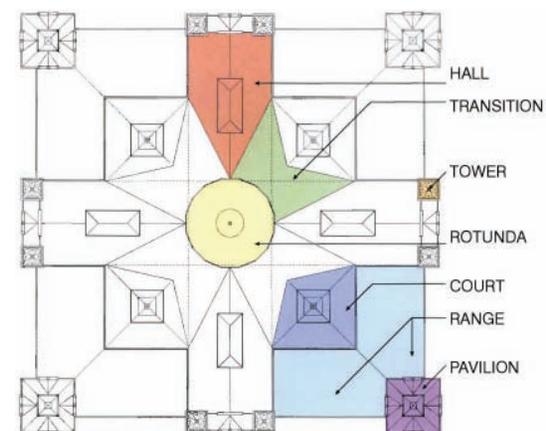
4. Identification plan

Roofs

The roof is the appropriate location in this building to transition from the interior to the exterior as the interior forms of the roofs were intentionally left to be understood from the interior of the building. Initially, the roofs had an interior metal lath and plaster affixed to the underside of the purlins; however, due to movement, condensation, and lack of keying, this finish failed almost immediately upon completion. In 1903, Rathbun reported that the finish was completely removed from the ranges and that the painted underside of the structure was “not to be out of keeping with its surroundings.”

The slates are nailed to small pieces of wood, fitted into small L-shaped pieces of iron, and the plaster of the ceiling is laid directly upon the rough inner surface so formed. Besides the lanterns before mentioned, a number of small skylights and ventilators have been built over some of the ranges and courts, especially where the recently constructed galleries have interfered with the lighting.

The entire framework, as well as the inner sheathing of the roofs, is (sic) exposed to view, this plan having been followed in the interest of economy.¹⁰

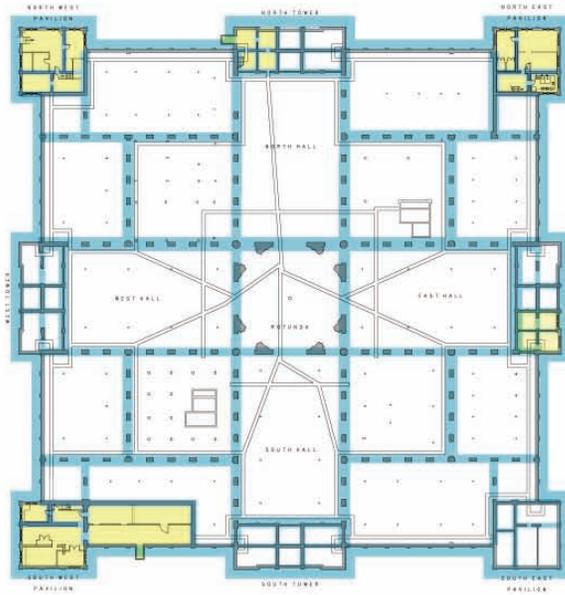
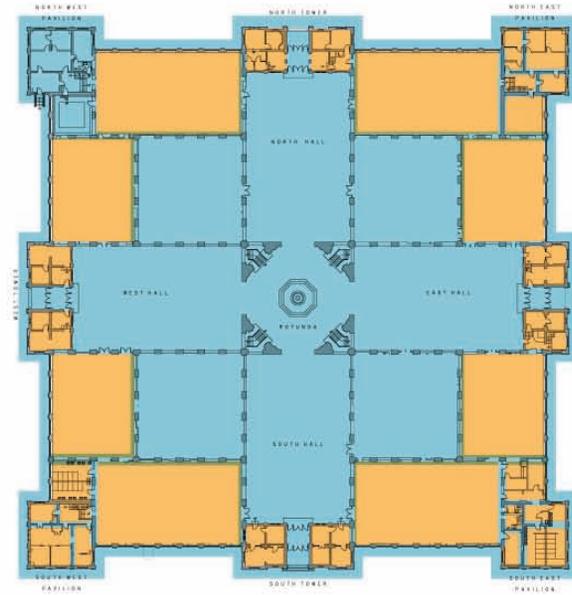
Diagram of Design Significance

The ground floor plan represents the interior hierarchy of the museum such that the Rotunda, halls, and North West Annex are of the highest level of significance. The Rotunda is the centralizing feature and is understood externally and internally as the most prominent volume. The halls, radiating from the Rotunda, are of equal significance as they define the main axes of the building and provide the largest exhibit spaces. The courts follow at this same level of significance as they join the volume of the halls and are the only three-story connections between the halls. The ranges and pavilions also follow in significance. The ranges were designed as single story public spaces to wrap the courts. The pavilions served as the metaphorical and literal corner posts for the structure and museum. They included the offices and labs that maintained the quality of the exhibits and provided for continued scientific research. The North West Pavilion is noted at a higher level of significance as it was the director's office. The towers and remaining annexes are the least significant spaces in terms of function and design with spaces that served as administrative offices and circulation connections between the pavilions and ranges.

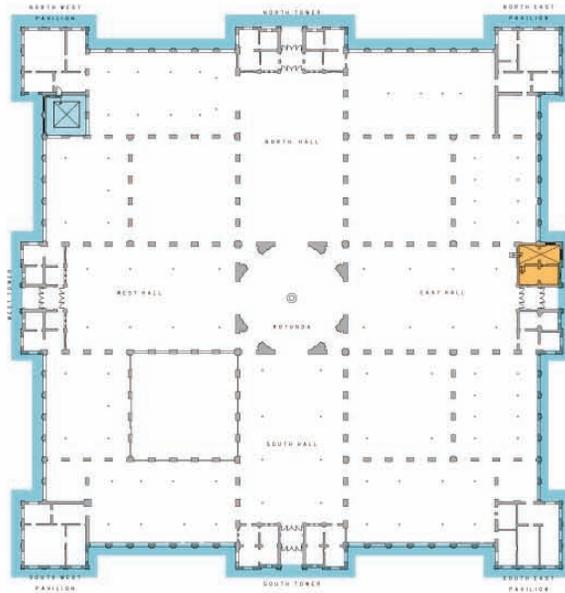
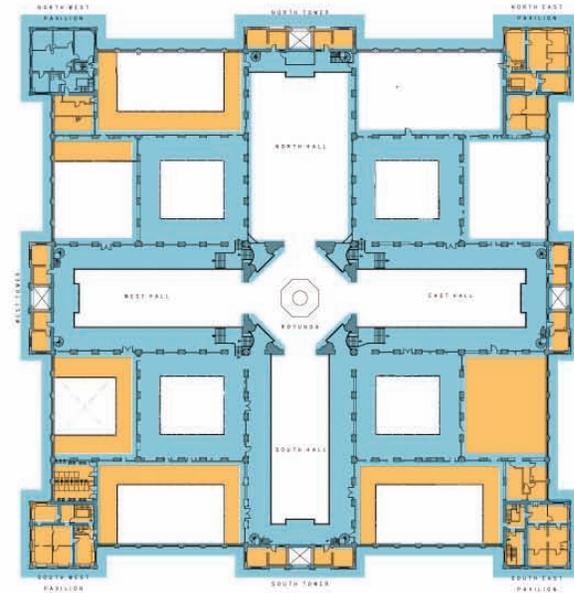
Diagram of Design Significance

The second floor plan continues to illustrate the same hierarchy of space as the ground floor with the exception of the galleries found in the halls. These spaces were not constructed with the initial design and modify the as-built volume of the halls. Earlier renderings did explore the construction of galleries in the halls but it was not executed in the final construction. Galleries in the 1881 plan were limited to ends of the halls and intended as viewing stations and access platforms at the base of the spiral stairs into the towers. Because the construction of the galleries began in 1896, with discussions beginning about the option of galleries soon after the 1881 opening of the building, these elements have an established level of significance within the building as circulation, viewing points, display, and storage areas.

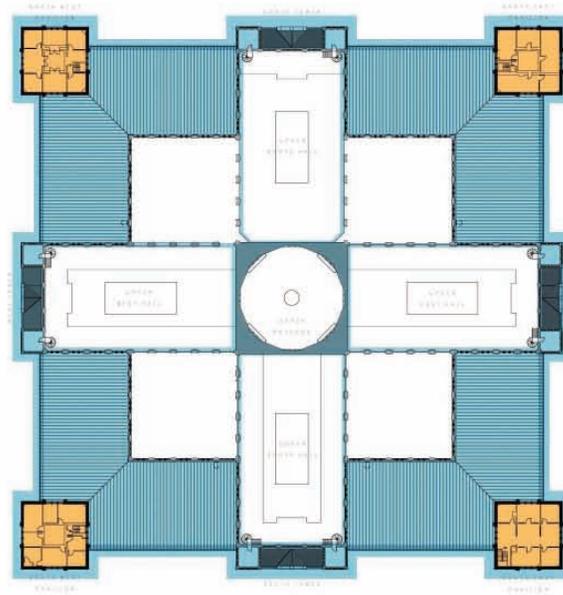
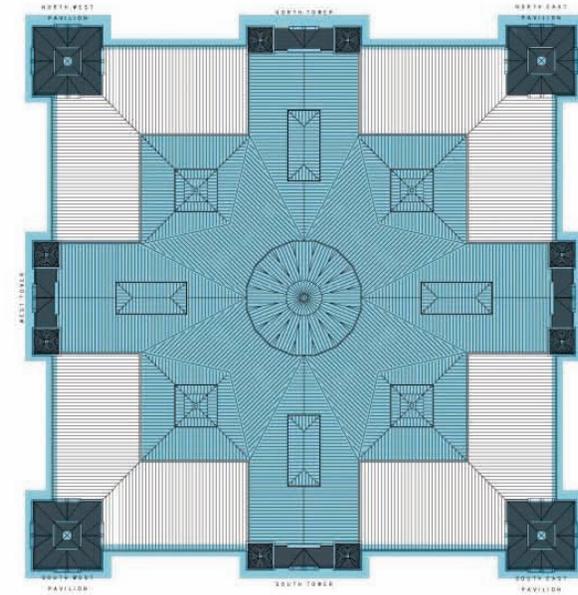
Diagram of Design Significance

The roof plan presents the high significance attributed to the entire roof and perimeter of the building.

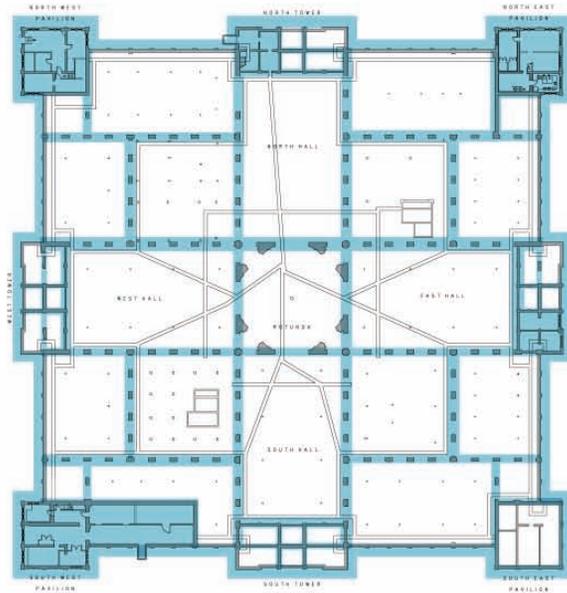
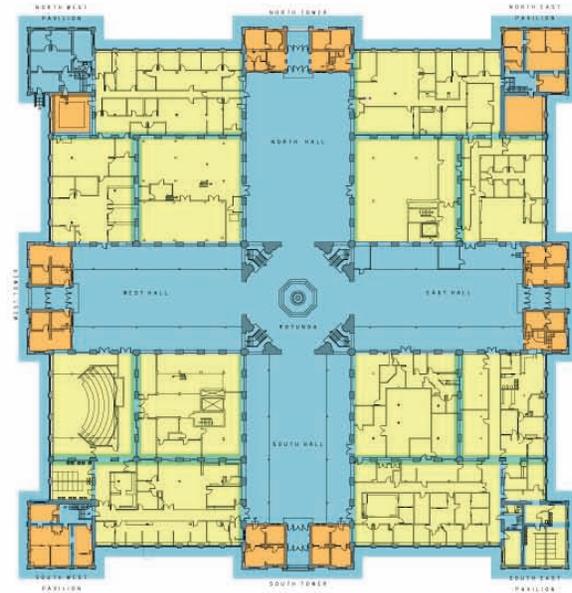
The ground floor Rotunda and halls retain the highest level of integrity of original materials and finishes. The North West Pavilion is less significant and retains a high degree of significant fabric. The courts, ranges, remaining annexes, pavilions, and towers have had modifications on the ground floor such that the load-bearing masonry walls are the remaining historic fabric. The subfloor structure in the courts and ranges remains however the finishes are modern. The perimeter of the building is documented to show the high level of integrity of materials around the entire perimeter.

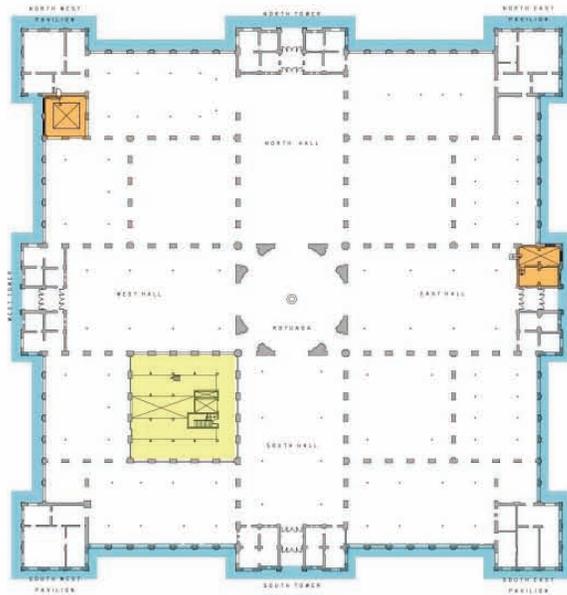
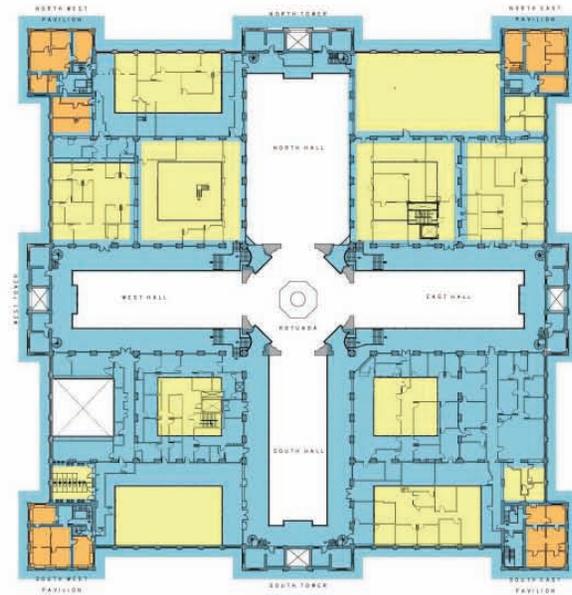
The second floor plan illustrates the locations of the remaining galleries. In all locations where gallery floors remain, except the North West Annex and the South West Range, the floor is a part of the entire second floor system that creates two levels out of a space that was a single volume with a gallery during the Period of Significance. The galleries in the North West and North East Courts were removed during the 1973 renovations and new concrete floors span these spaces creating two levels where there was a single volume with a gallery during the Period of Significance. Original material has been moved and modified within all four pavilions.

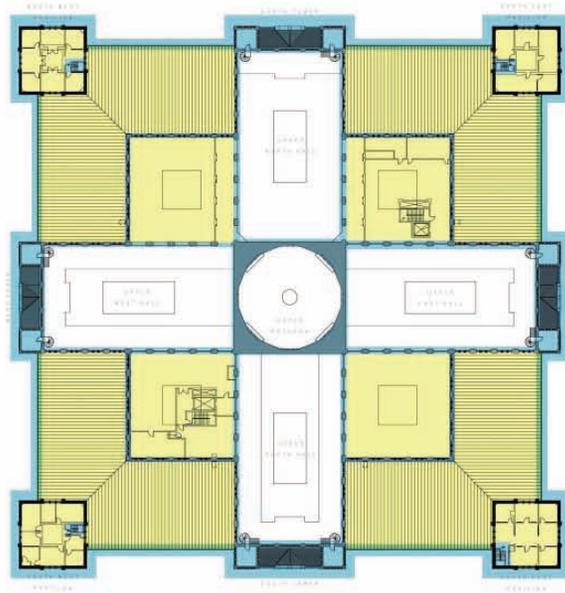
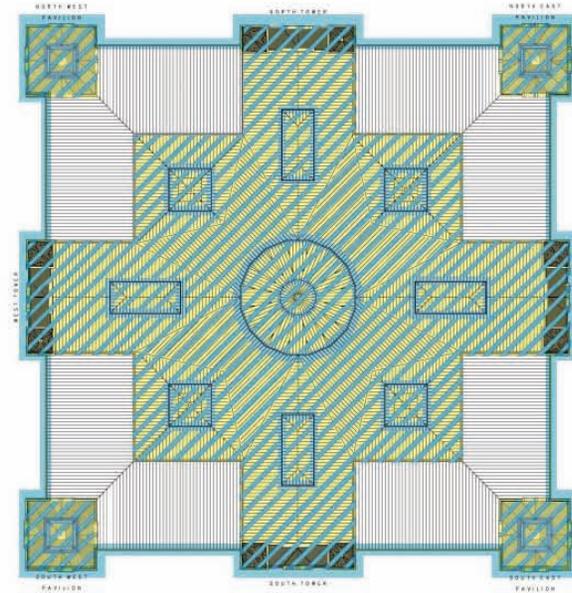
Diagram of Significant Fabric Integrity

The stairs in the third floor pavilions remain from the original construction while the spaces are significantly changed. The floors introduced into the courts were completed after the Period of Significance. The range roof cladding was entirely replaced in 1982. The truss girders remain but were also modified at this time. New steel purlins were added between the existing trusses and a new steel beam was installed along the top chord of the trusses. Refer to Section 2.4.1 for a detailed description of the significant modifications to the framing at these locations.

The pavilion, tower, hall, court, transitional and Rotunda roofs have been re-clad with new materials over time. The pavilions and towers continue to be clad with slate while the other roofs have different materials. All of these locations retain their initial structural support with minor or additive modifications to the framing as discussed in Section 2.4.1.

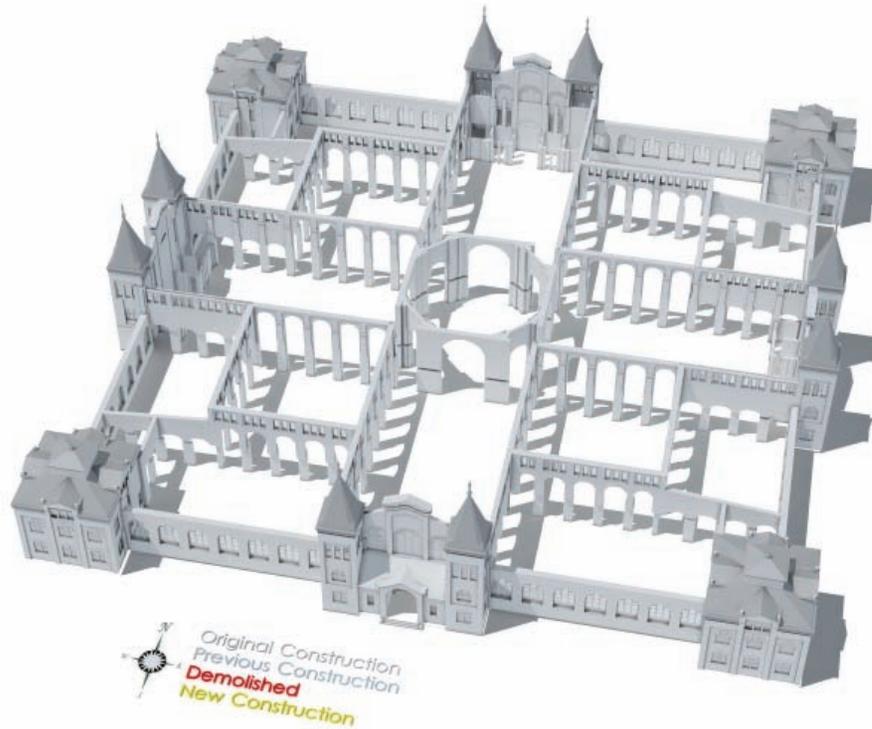
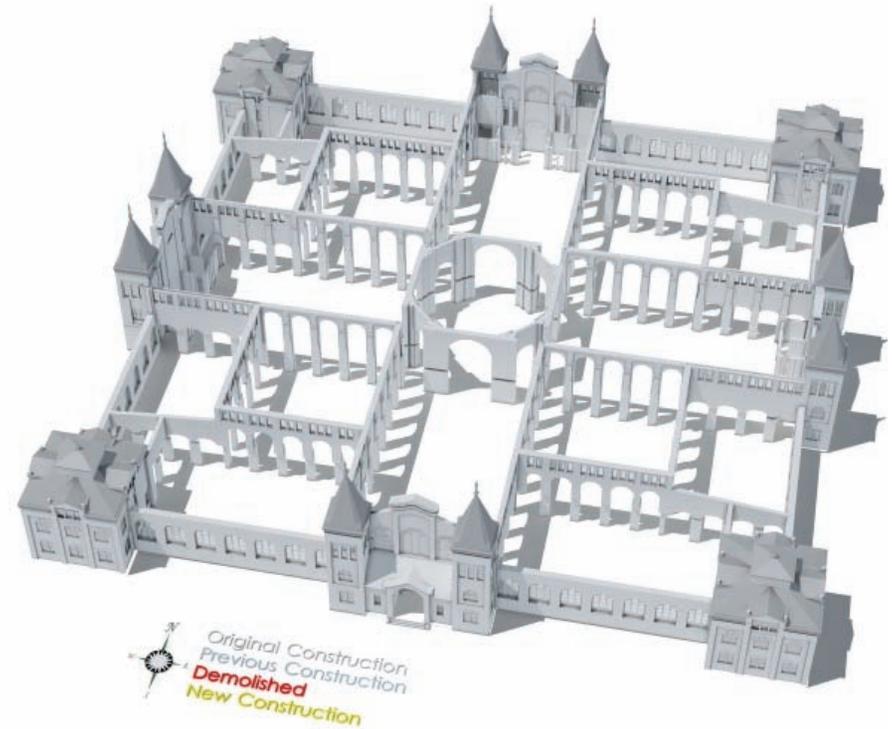
This diagram represents the appearance of this level at the completion of construction.

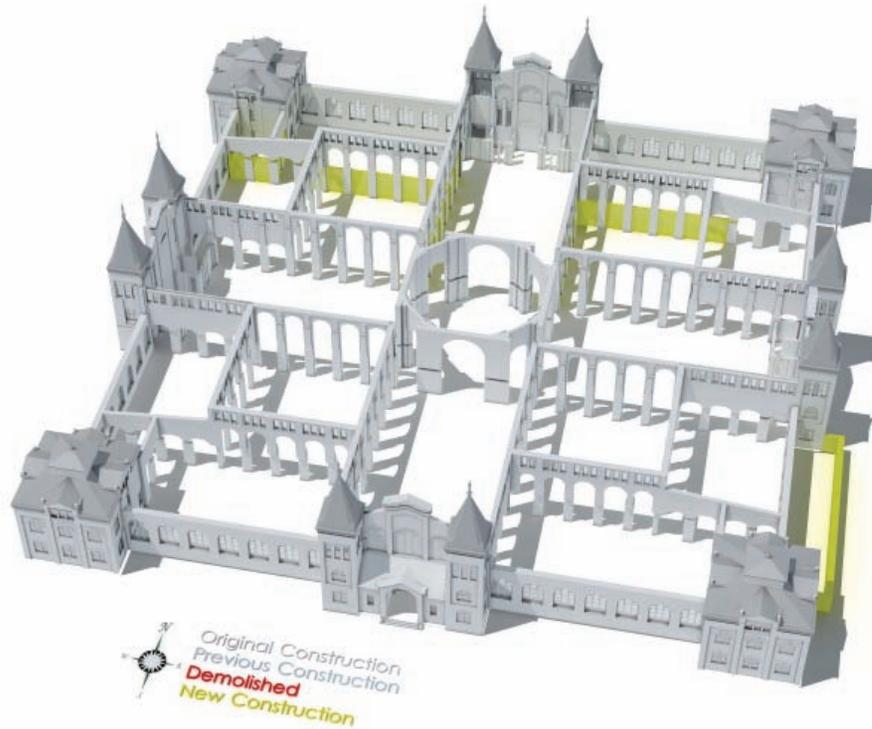
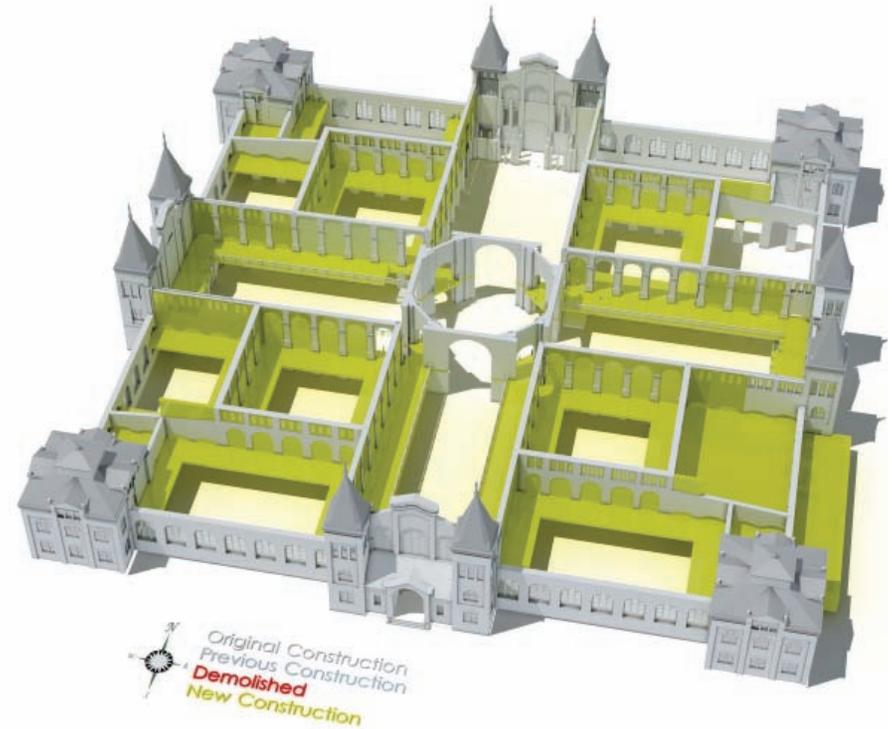
Based on the changes in function the walls along the south sides of the West North Range and East North Ranges were enclosed. Other spaces were enclosed by temporary construction, draperies and exhibits by this time but as they are not represented they are not permanent construction. (Note: This configuration is consistent with the condition of the building from the end of 1902 through 1903)

By 1902, all of the galleries shown were constructed and used for storage, display circulation and viewing. At the second floor level, all of the primary spaces were separated from each other partly driven by the need for more wall display space, the separation of spaces due to the changes in functions and the attempt to manage fire and life safety issues by separating spaces with rated and non-combustible construction.

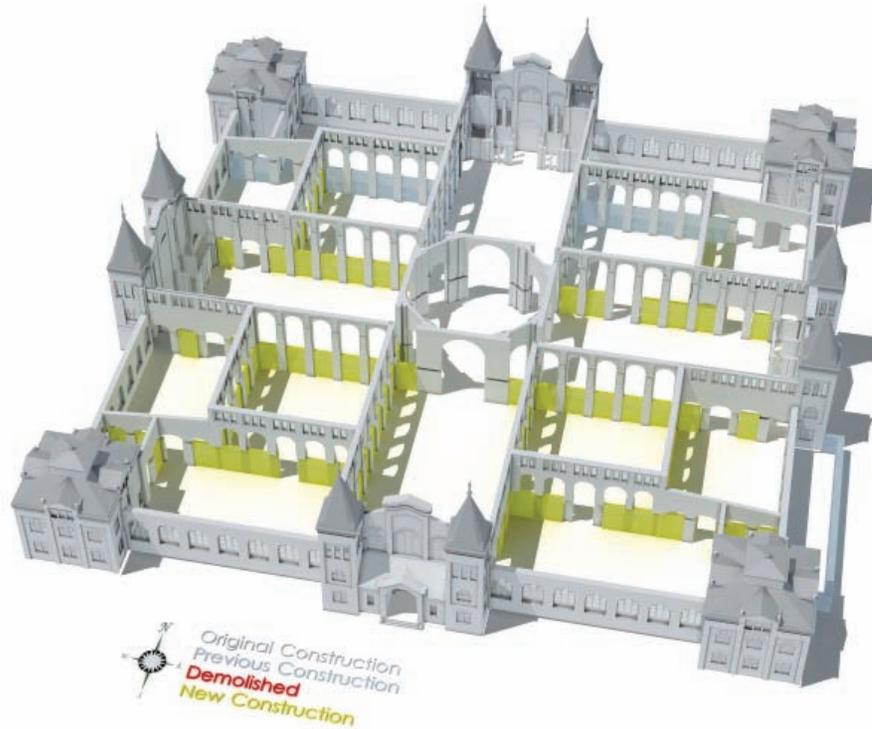
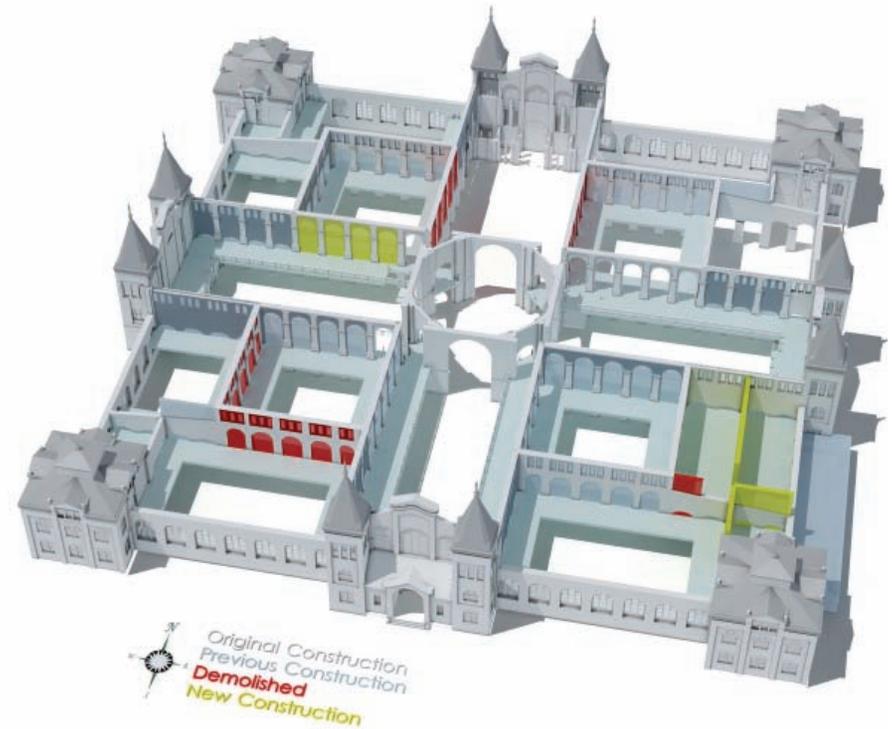
Infill between spaces continued within the AIB partly driven by the need for more wall display space, the separation of spaces due to the changes in functions and the attempt to manage fire and life safety issues by separating spaces with rated and non-combustible construction. A detailed discussion of the infill can be found in Sections 1.1 and 2.8.

The separation of spaces is modified based on exhibit needs and functions. A detailed discussion of the infill can be found in Sections 1.1 and 5.3.3.

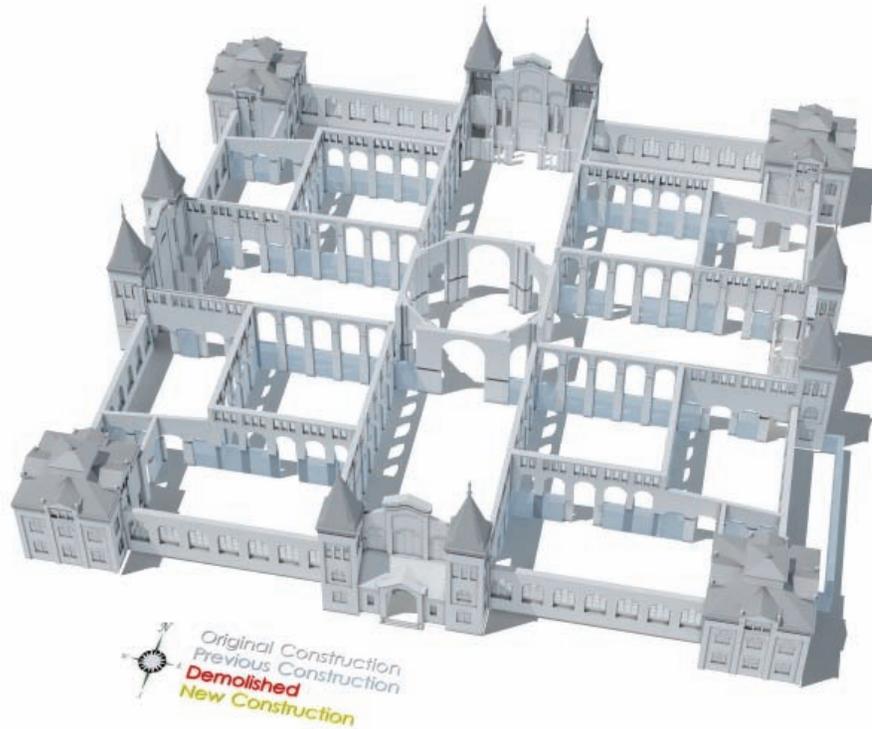
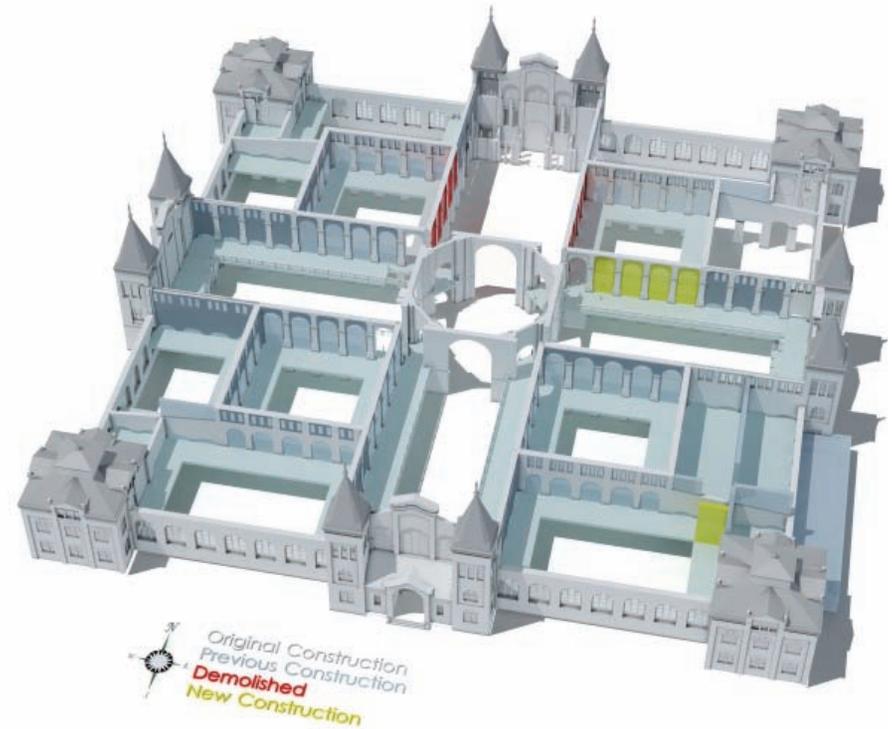
There is little change in the construction of the building although the functions of spaces and exhibits continue to change.

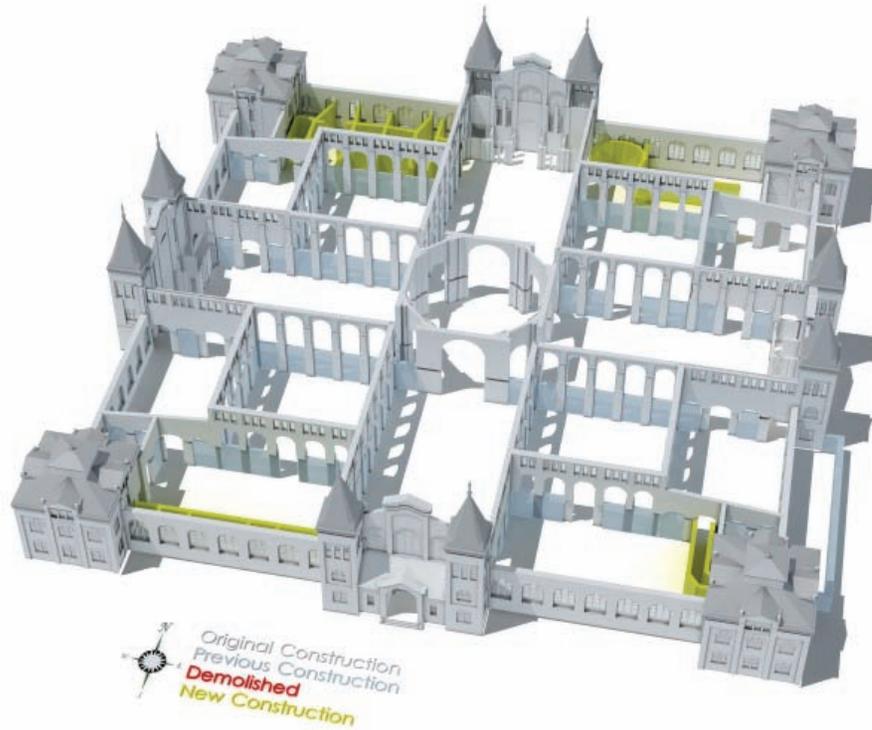
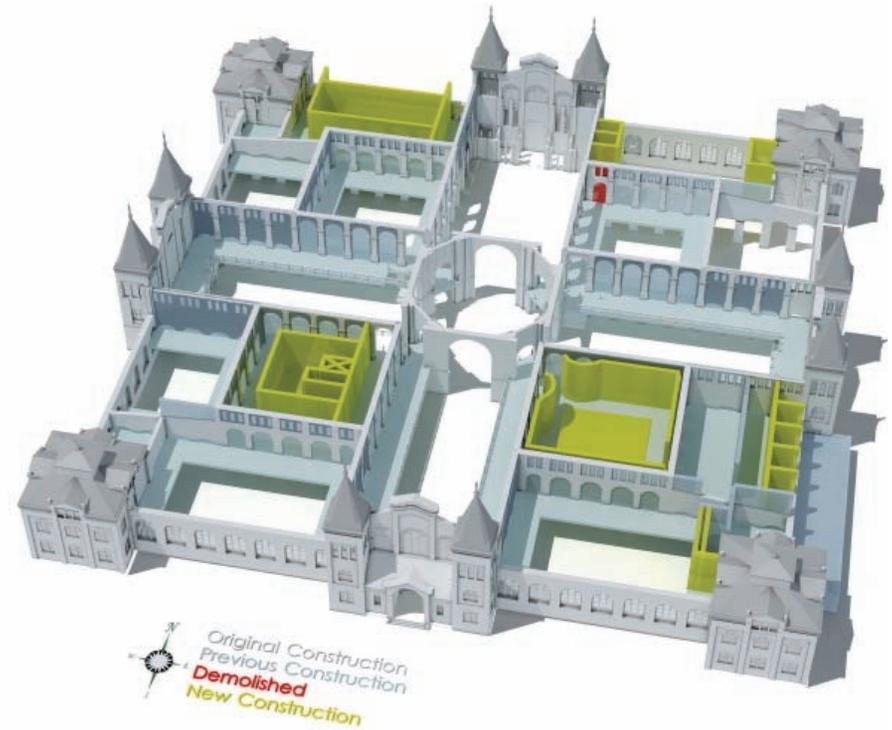
Increasing use of the space for administrative functions begins and sections of the building are infilled with partitions for offices. Interior spaces have some internal modifications due to exhibit and collections needs.

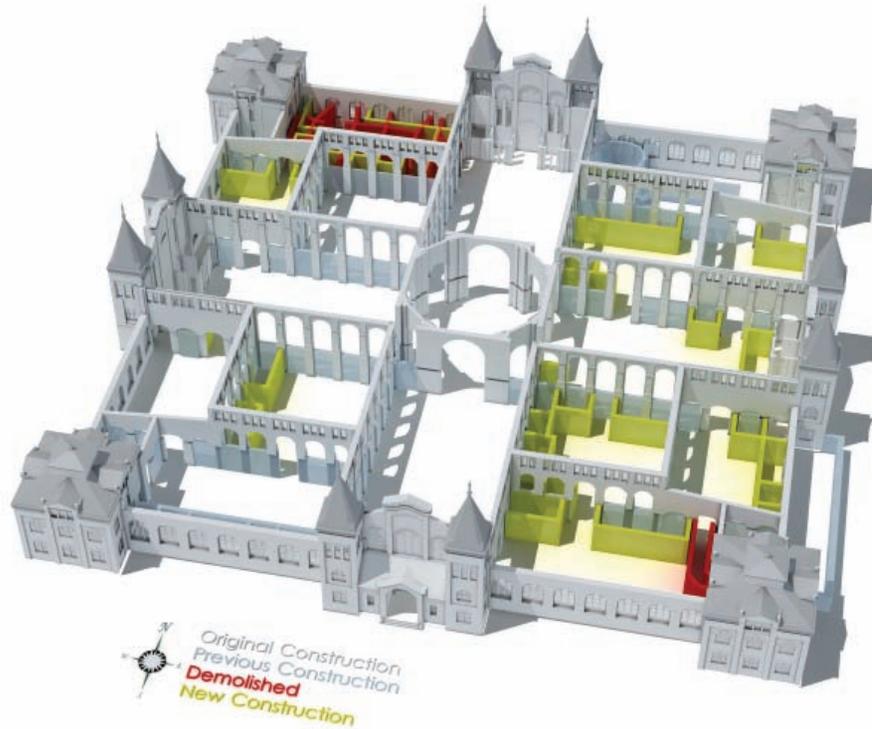
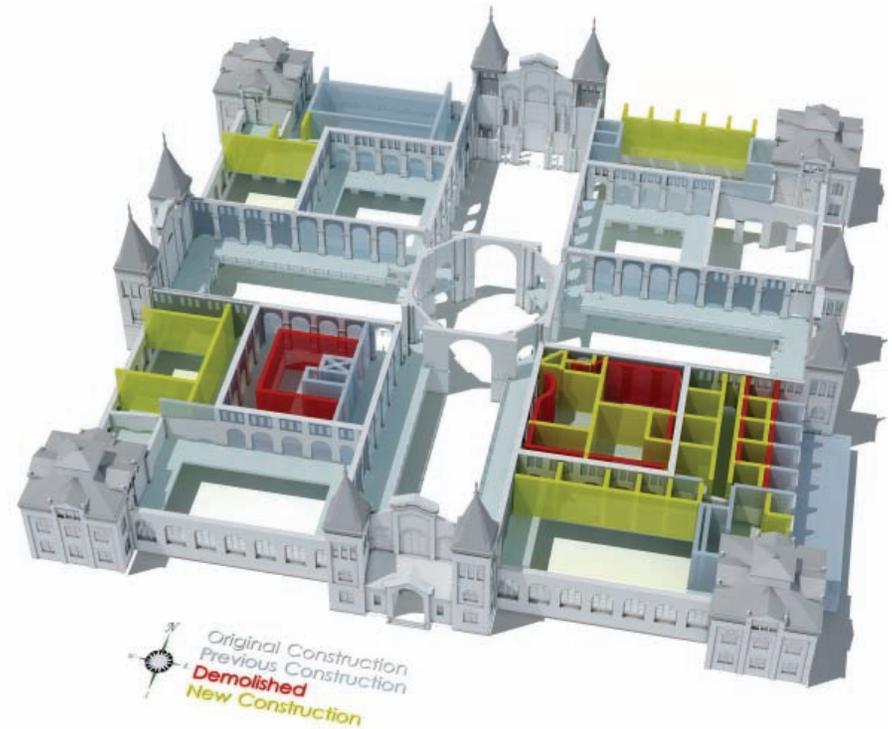
Increasing use of the space for administrative functions continues and more sections of the building are infilled with partitions for offices. Interior spaces have some internal modifications due to exhibit and collections needs.

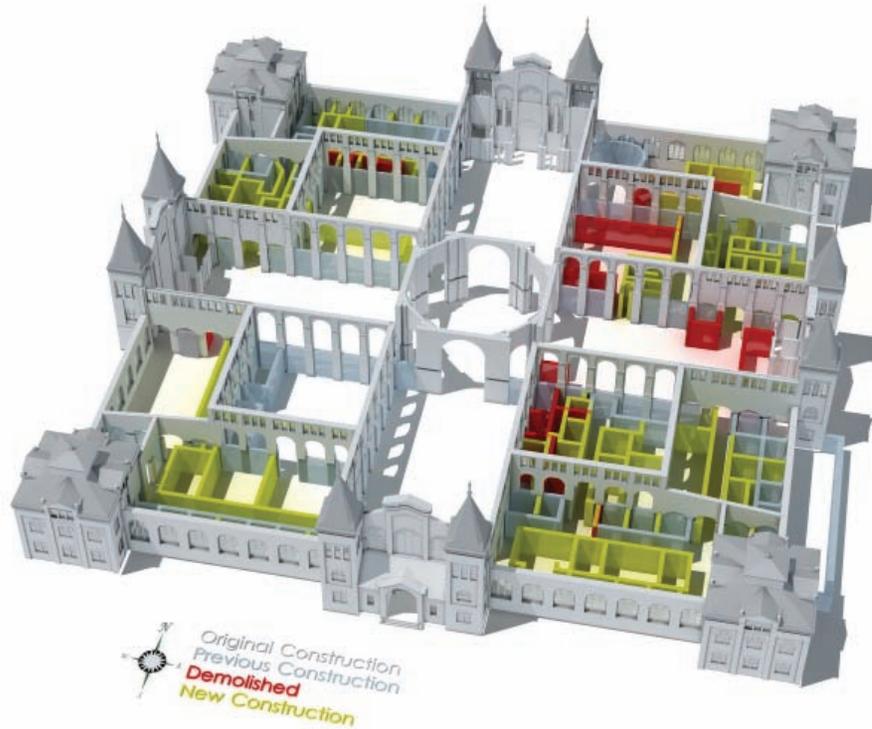
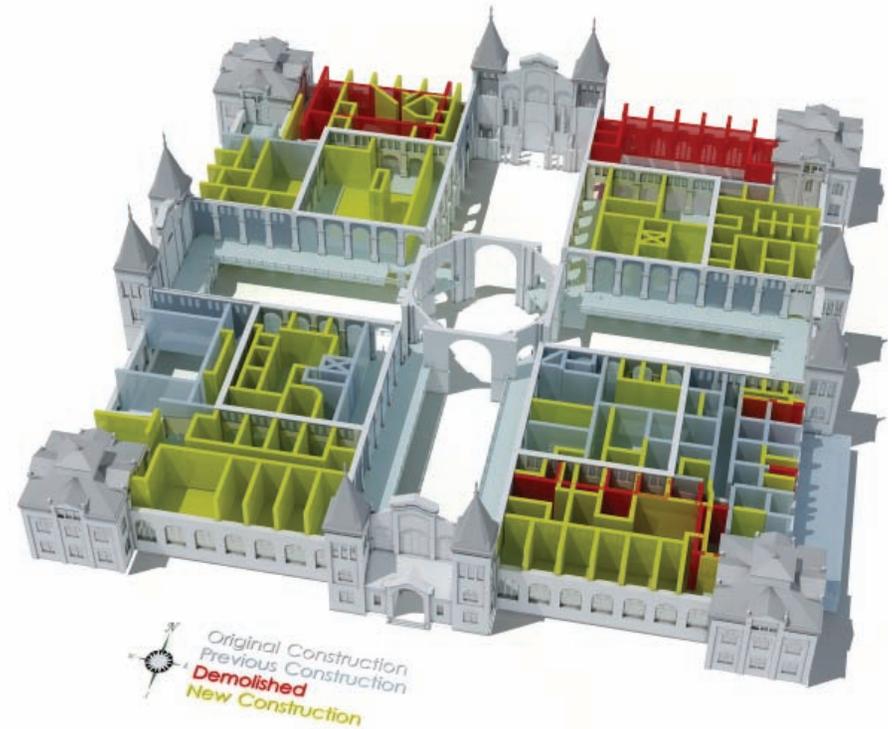
Increasing use of the space for administrative functions continues and considerable sections of the building are infilled with partitions for offices. Interior spaces have some internal modifications due to exhibit and collections needs.

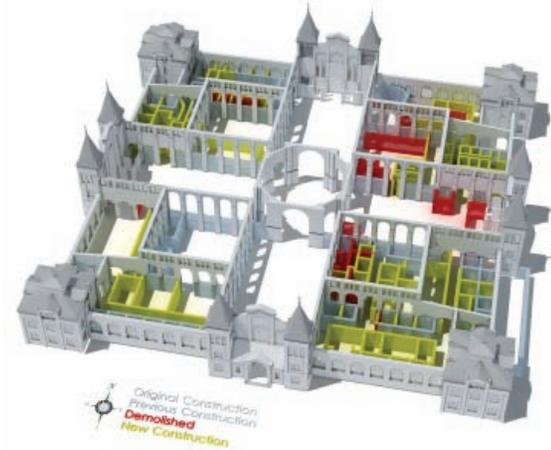
1902 Ground Floor Plan

Following is a comparison of the building between 1881, 1902 and 1976. They represent the initial design intent (1881), the configuration at the end of the Period of Significance (1902) and the most recent occupied documented condition (1976).

A detailed discussion of the infill can be found in Sections 1.1, 2.8 and 5.3.3. (Note: This configuration is consistent with the condition of the building from the end of 1902 through 1903)

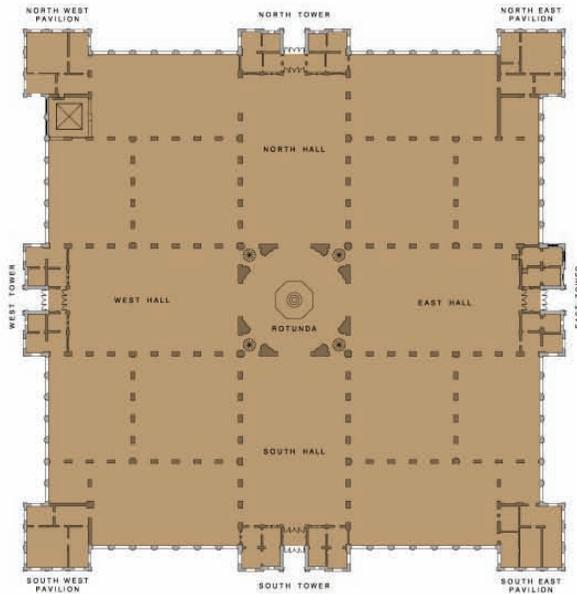
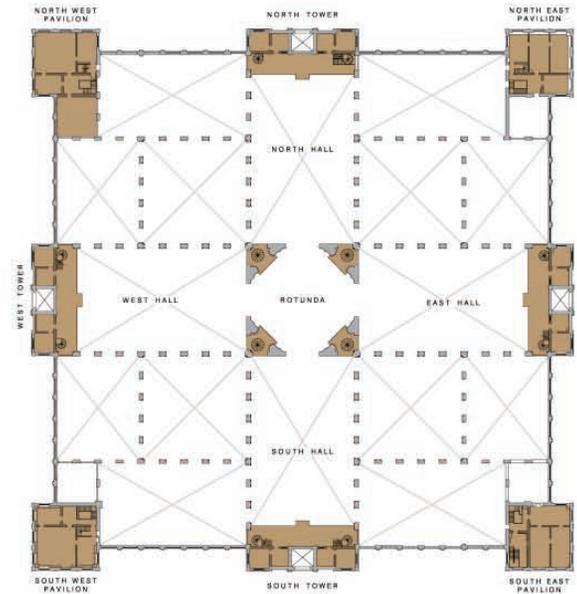
1881 - Temporary wood flooring installed for Garfield Inaugural Ball.

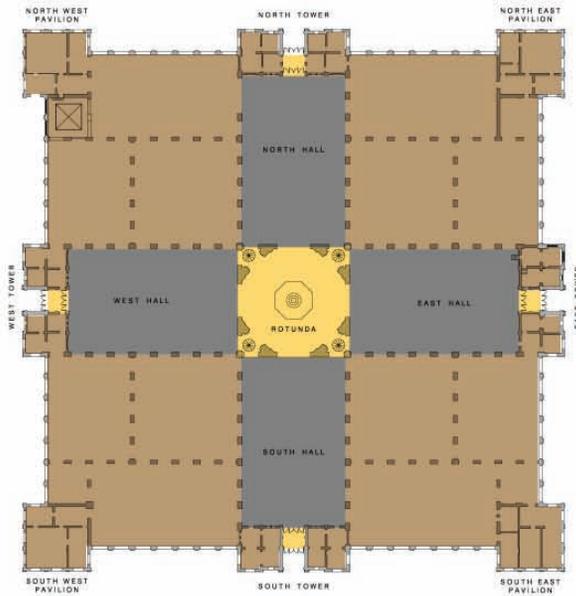
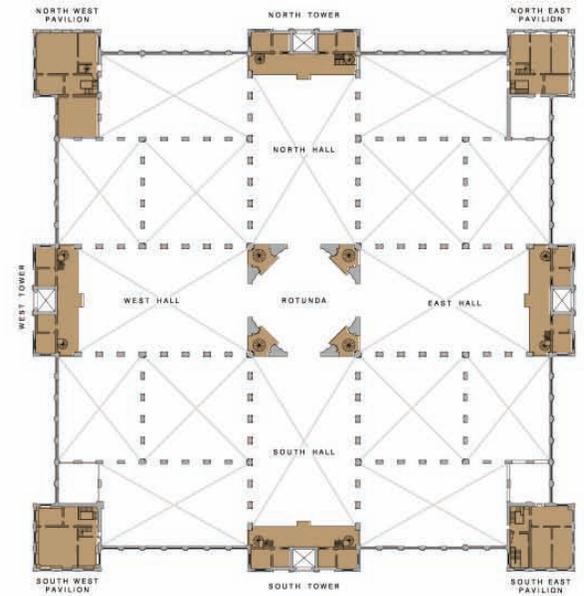
1881 - Stone floors installed at Main Halls.
Encaustic tile installed at Rotunda.

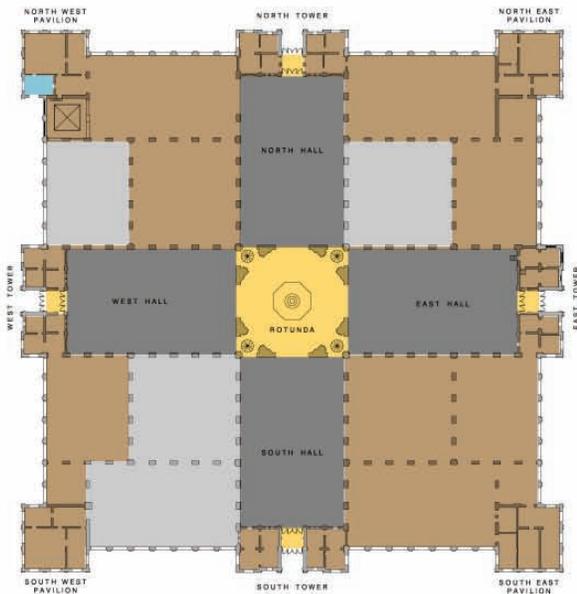
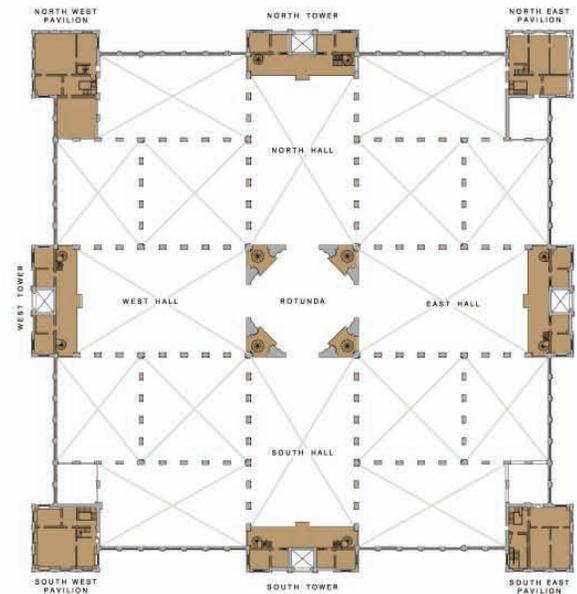
1889 - Wood floors are removed and replaced with granolithic or terrazzo flooring in unspecified locations.

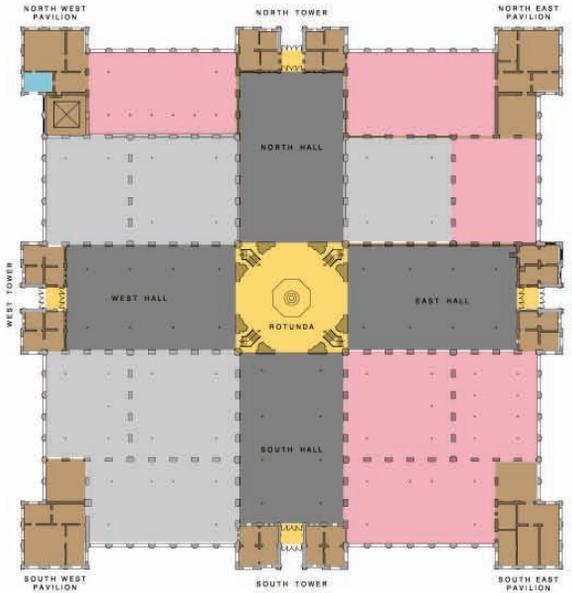
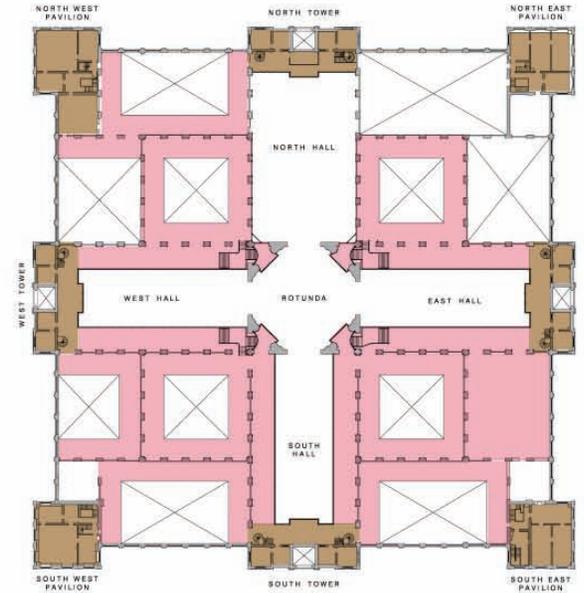
- 1898 - Concrete floors replace wooden floors in two ranges.
- 1899 - Two old wooden floors replaced with terrazzo.
- 1901 - Last of temporary wood flooring replaced with terrazzo.

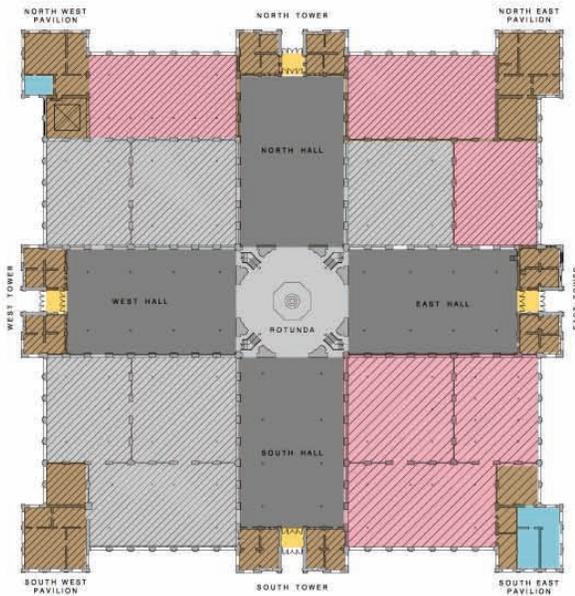
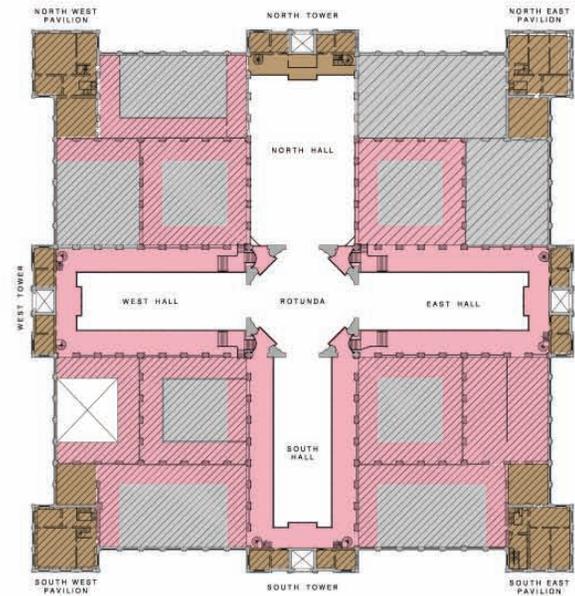
- 1915 - Encaustic tile and marble flooring of Rotunda and Main Halls extensively repaired.
- 1930 - Rotunda fountain removed. Floor finished with concrete.
- 1957 - Encaustic tile at Rotunda removed and replaced with concrete.

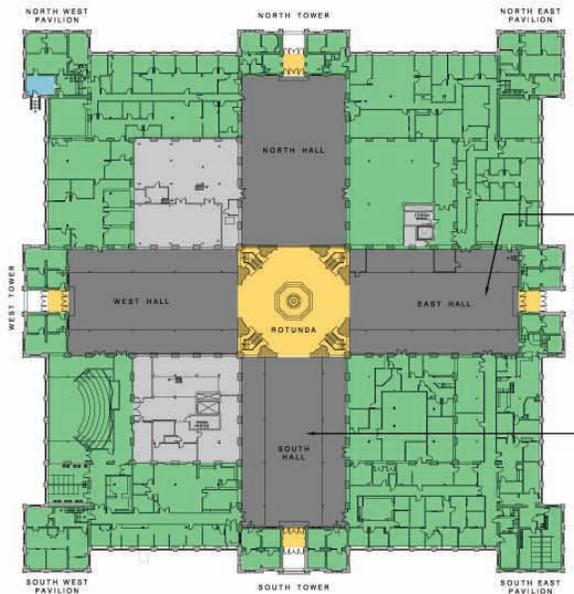
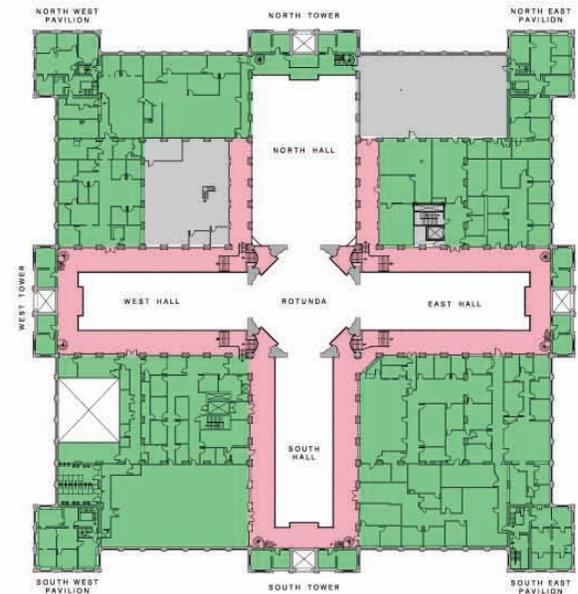
Per the Oehrlein Preservation Plan, carpet covered a large portion of the East Hall post-1990. Stone flooring was exposed at the time of the survey.

Per the Oehrlein Preservation Plan, a built-up floor was installed in the South Hall post-1976. Stone flooring was exposed at the time of the survey.
