A Description of the Building as Initially Constructed

Building History, Description and Significance

Chronology of Development and Use 1.2

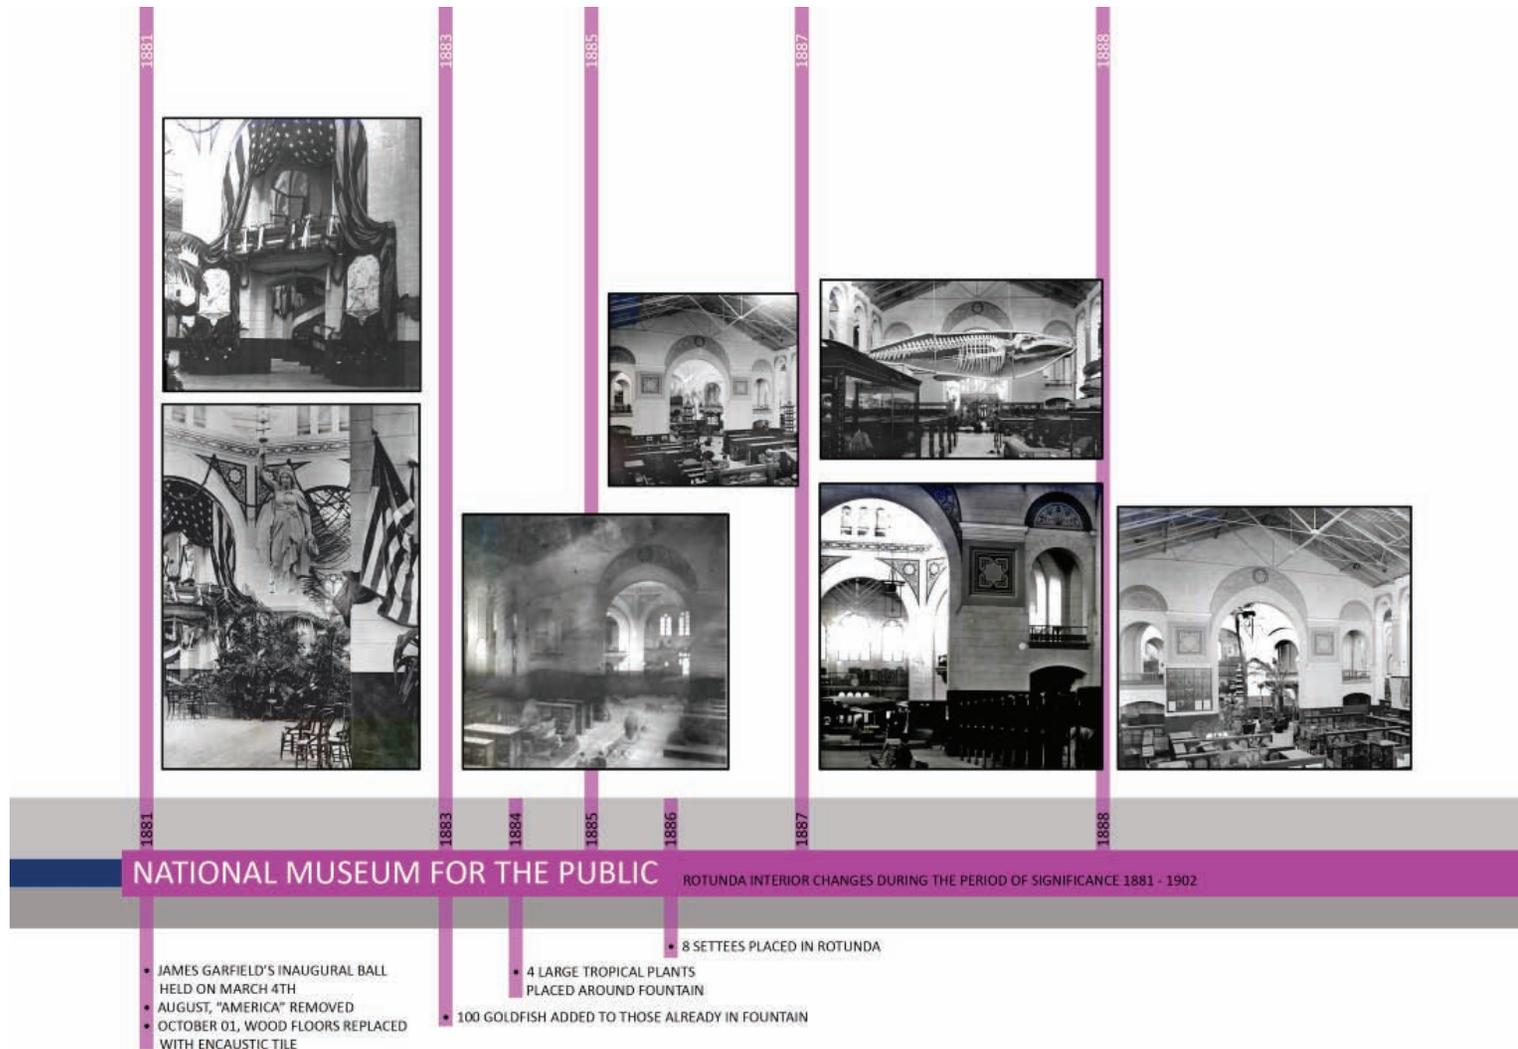
The following timeline documents photographs and events found that relate to the Rotunda during the Period of Significance.

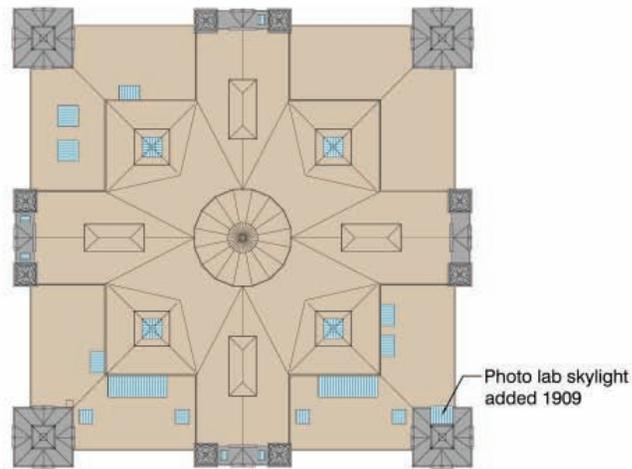
1906 to 1909

Notes:
 1905: Extra skylights installed over all ranges. No locations are specified. Diagram based on historical photographs.
 1906 to 1909: Complete roof replacement- majority of slate roofs converted to tin.

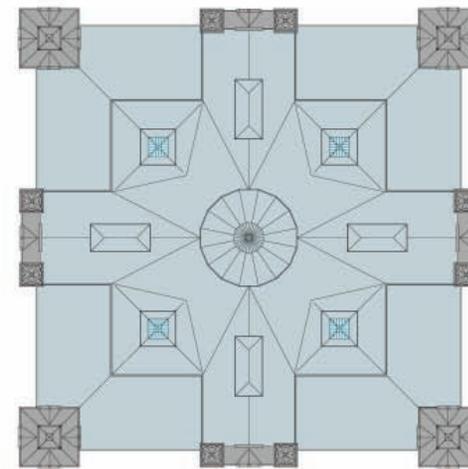
1981 to Present

Notes:
 1981 to 1984: Complete roof replacement.

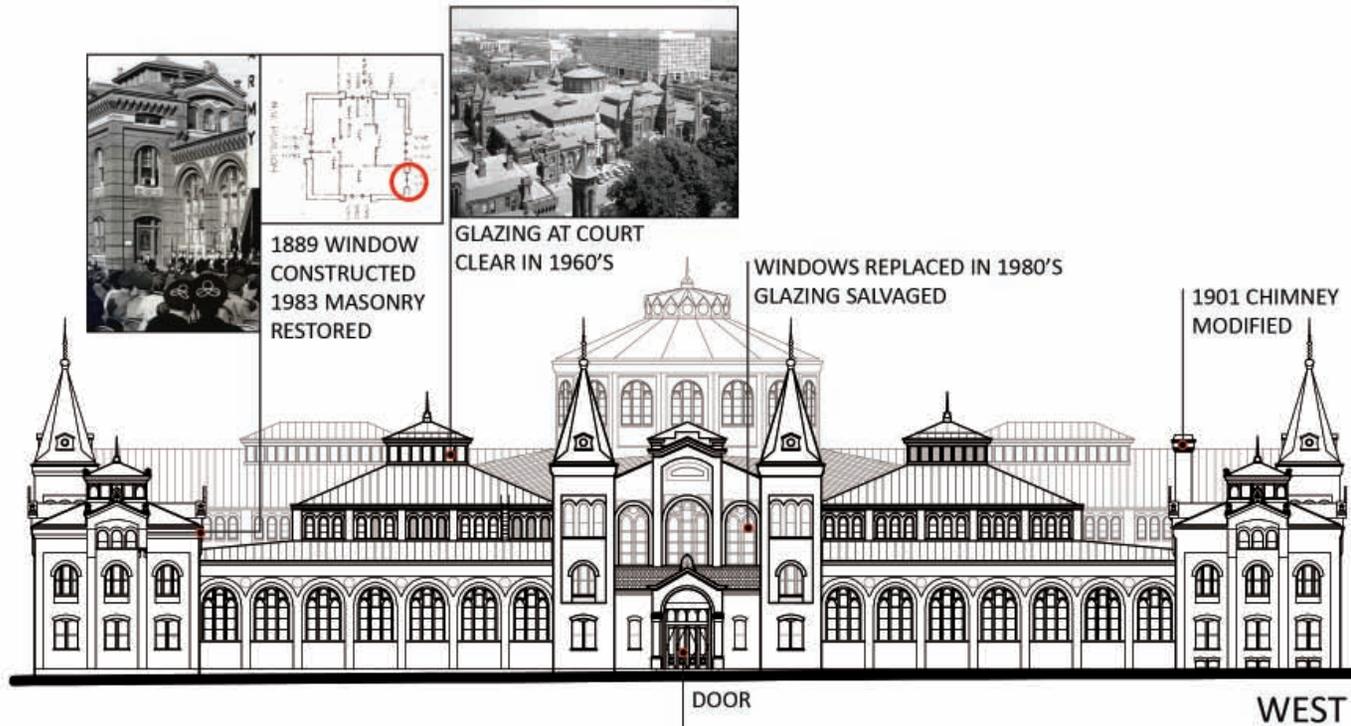
1881 ORIGINAL DOORS AND GATES	1890 DOOR MOVED TO OUTSIDE ARCH	1898 DOOR REMOVED, WINDOW CONSTRUCTED	1993 RAMP	
		<p>SECTION</p> <p>EXTERIOR ELEVATION</p>		1986 TEMPORARY RAMP 1976 DOOR RECONSTRUCTED 1979 GATE RESTORED & REINSTALLED

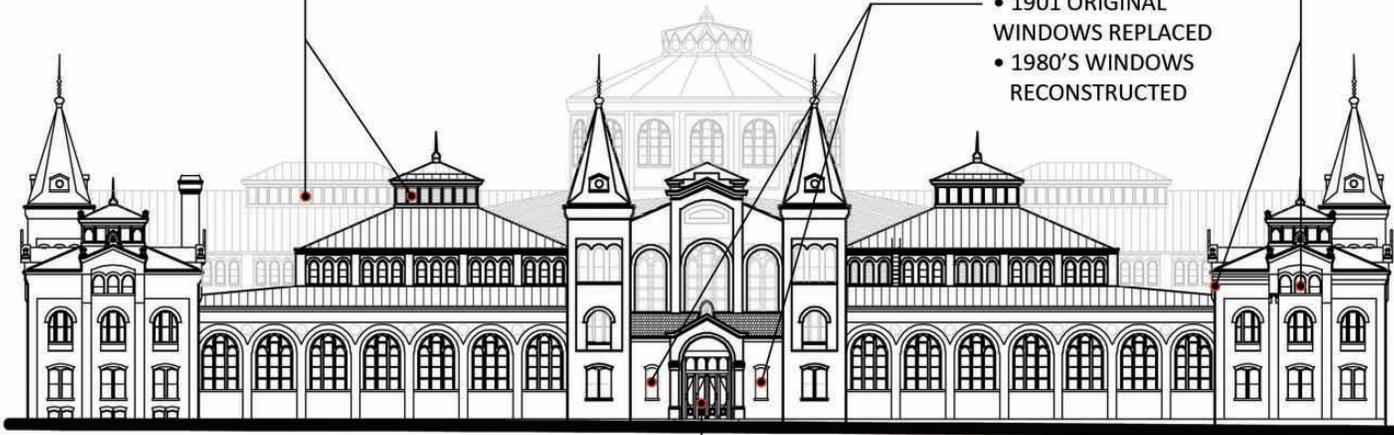
ENTRANCE
DOOR

WINDOWS @
PHOTO LAB
• 1909 - ADDED
• 1984 - REMOVED,
WINDOWS
RECONSTRUCTED

• 1901 ORIGINAL
WINDOWS REPLACED
• 1980'S WINDOWS
RECONSTRUCTED

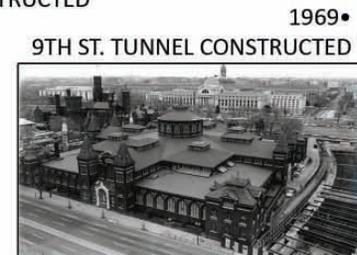
1985 GATES
RECONSTRUCTED

1969•

9TH ST. TUNNEL CONSTRUCTED
